Inspection Report

Permit Number:	C0150032
Inspection Type:	PARTIAL
Inspection Date:	Thursday, August 12, 2010
Start Date/Time:	8/12/2010 11:00:00 AM
End Date/Time:	8/12/2010 1:00:00 PM
Last Inspection:

Site: CRANDALL CANYON MINE

DOGM visited the Crandall Canyon Mine to inspect 1) the continued cleanout of the water treatment system settling basin, and 2) the reported release of coal to Crandall Creek resulting from heavy rains between 8/5 and 8/9.

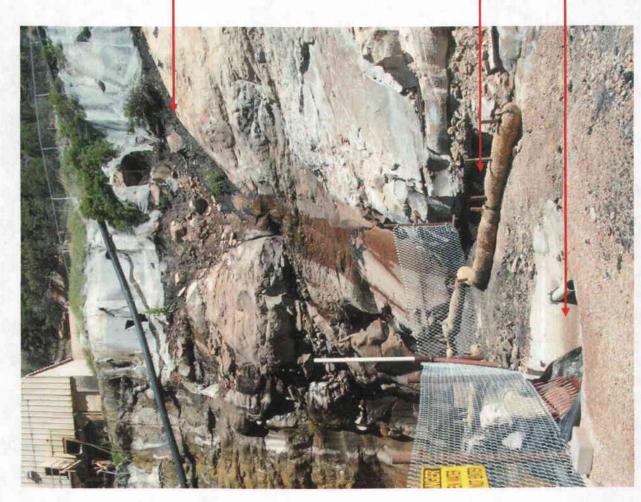
According to mine personnel, heavy rains between August 5 and 8, 2010 caused a debris slide of coal material from the sandstone face above the minewater treatment settling basin outfall. The slide occurred sometime between the afternoon of August 5 and the morning of August 9 (mine personnel were not present a the time of the slide). Coal material from the rock face entered the settling basin, DD-10 (reporting to the primary sediment pond), and the short ditch at the outfall of the treatment system settling basin (reporting to the 6-ft CMP bypass which in turn reports to Crandall Creek).

Source of coal – heavy rains caused
 a debris flow on this rock face

-The Operator constructed this ditch to contain future slides; ditch reports to primary sedimentation pond.

-Coal washed down from the rock face into the 002 outfall pipe

In response the debris slide and in an effort to help reduce the potential for future releases of coal and sediment to Crandall Creek, a ditch had been constructed at the base of the sandstone face directing drainage (and associated debris) to DD-10. Excelsior logs were placed at the crest of the ditch.
